APOLLO 9

30-DAY FAILURE AND ANOMALY LISTING REPORT

APOLLO 9
30-DAY FAILURE AND ANOMALY LISTING REPORT

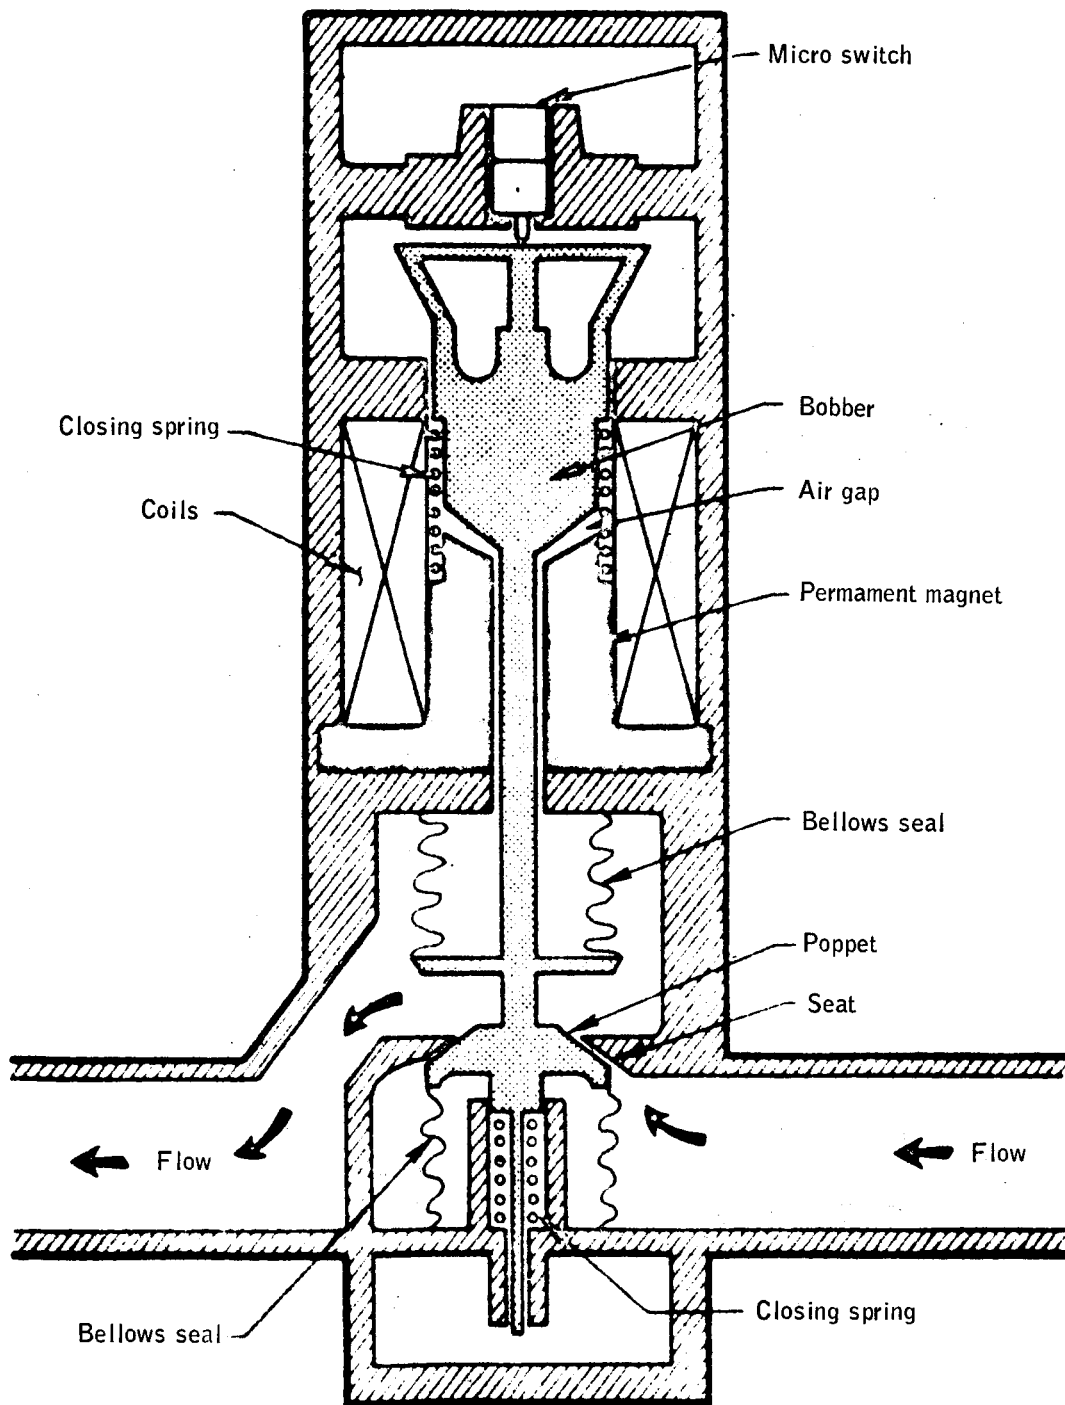
Figure 2.- Cross section of reaction control system isolation valve.

5. Valve closure caused by mechanical shock at separation of the command and service modules from the adapter - Shock tests were run on a service module reaction control system valve to establish the level of shock that would be necessary to cause a normal valve to close. A cross sectional view of the valve is shown in figure 2. Results of the test indicate that a shock of about 80g could cause a valve to close. The shock resulting from the pyrotechnic charges used to separate the command and service modules from the adapter may have been between 40 and 100g (analyses to refine these values are in progress).

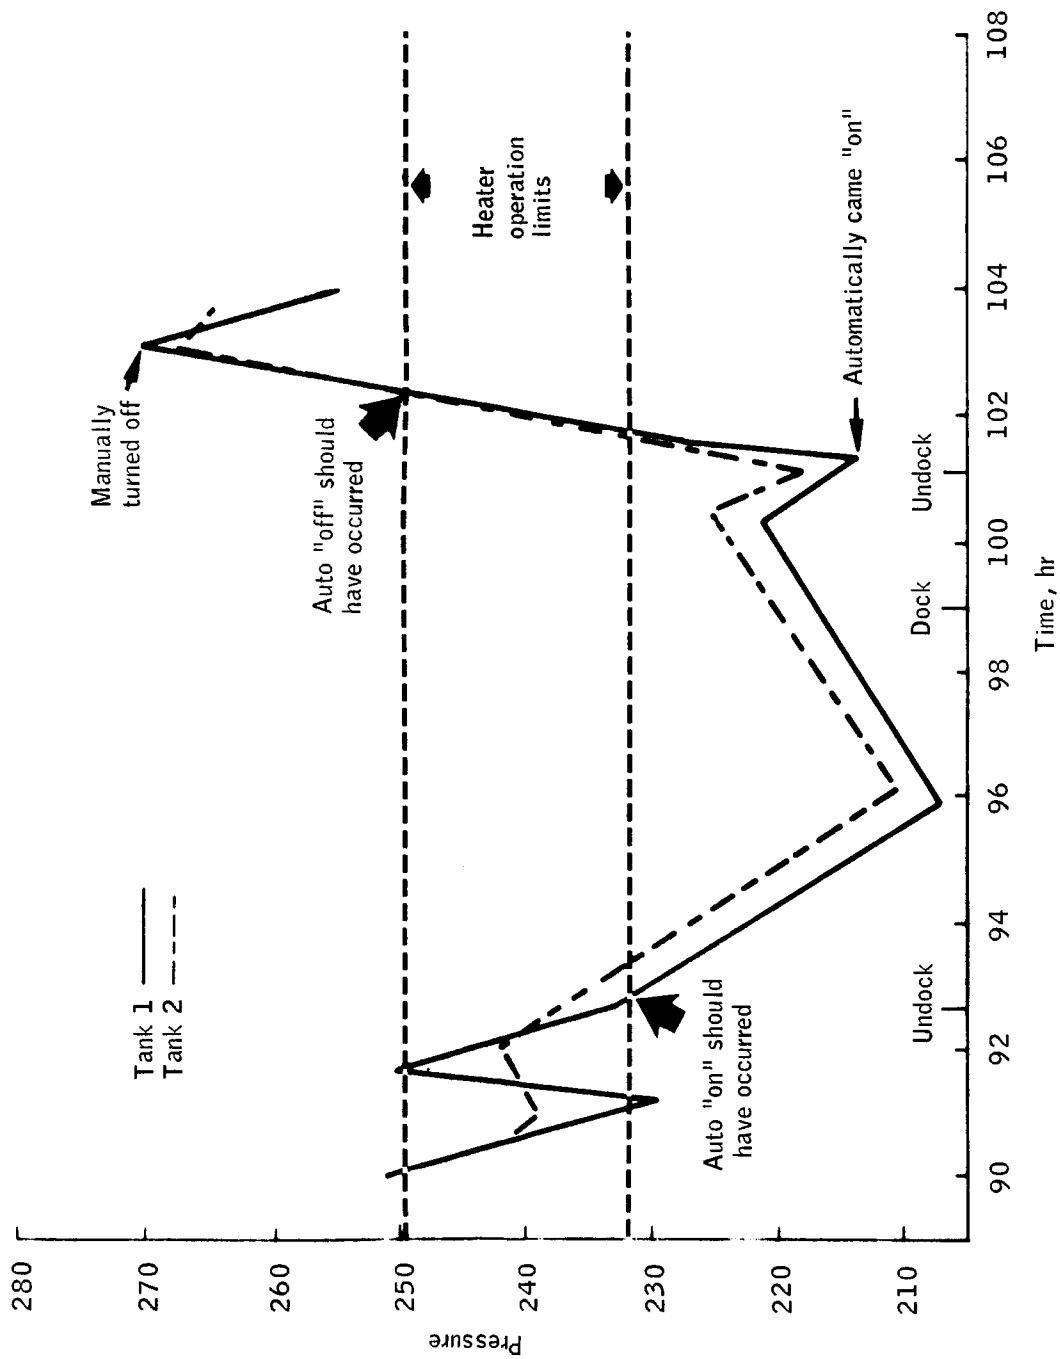
Figure 6.- Hydrogen tank pressure - heater operation.

During the flight, the automatic pressure control system in the hydrogen tanks failed. The logic of the control system (fig. 5) is such that the pressure switches in both tanks must close in order for the heaters to be activated; however, opening of only one pressure switch will deactivate the heaters. The first indication of failure was noted at 93 hours, shortly after the initial undocking, when the heaters were not automatically activated (fig. 6). At approximately the time of the final lunar module undocking, all hydrogen tank heaters came on and pressurized the tanks to about 270 psia, which required that the heaters be turned off manually.

Since the first failure (failure to turn on) would have required one pressure switch to fail open and the second failure (failure to turn off) would have required that both pressure switches fail closed, the switches can be ruled out. The most probable cause for the failures was an intermittent condition in the motor or its control circuit (including the power line, ground, and the terminal board for 16-gage pins) resulting from the undocking shock (see fig. 5). Sixteen-gage terminal boards have been the source of intermittent contact during vehicle ground tests.

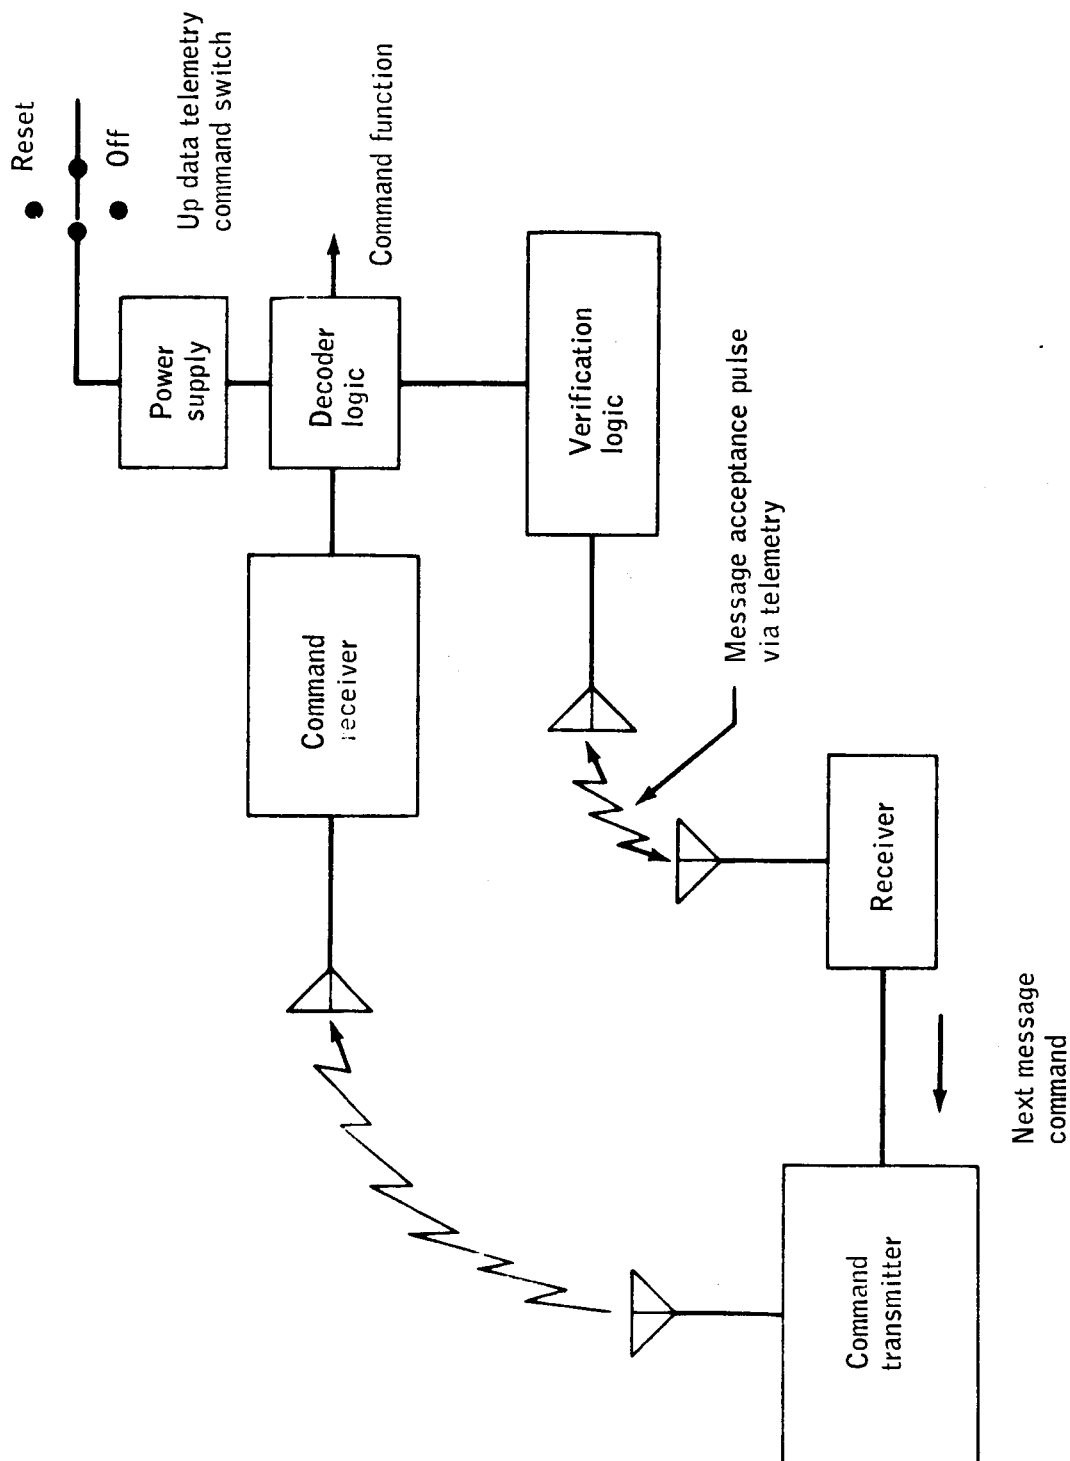
Figure 7.- Command link.

At approximately 109 hours, the spacecraft would not respond to multiple uplink real-time commands. Ten hours later, the crew cycled the power switch to the command system, restoring normal operation (fig. 7). The first of multiple commands was received by the command receiver; however, a message acceptance pulse was not transmitted to the ground receiver, which in turn sends a signal to the ground transmitter to send the next command. The ground override function was used on several occasions to transmit the next command; however, the spacecraft still did not respond. The problem existed over numerous ground stations and also was experienced once preflight; consequently, it has been isolated to the flight hardware. As yet, no conclusion can be drawn as to the cause of the discrepancy. Testing of the spacecraft hardware is to be completed by April 25. However, no corrective action is anticipated for spacecraft 106.

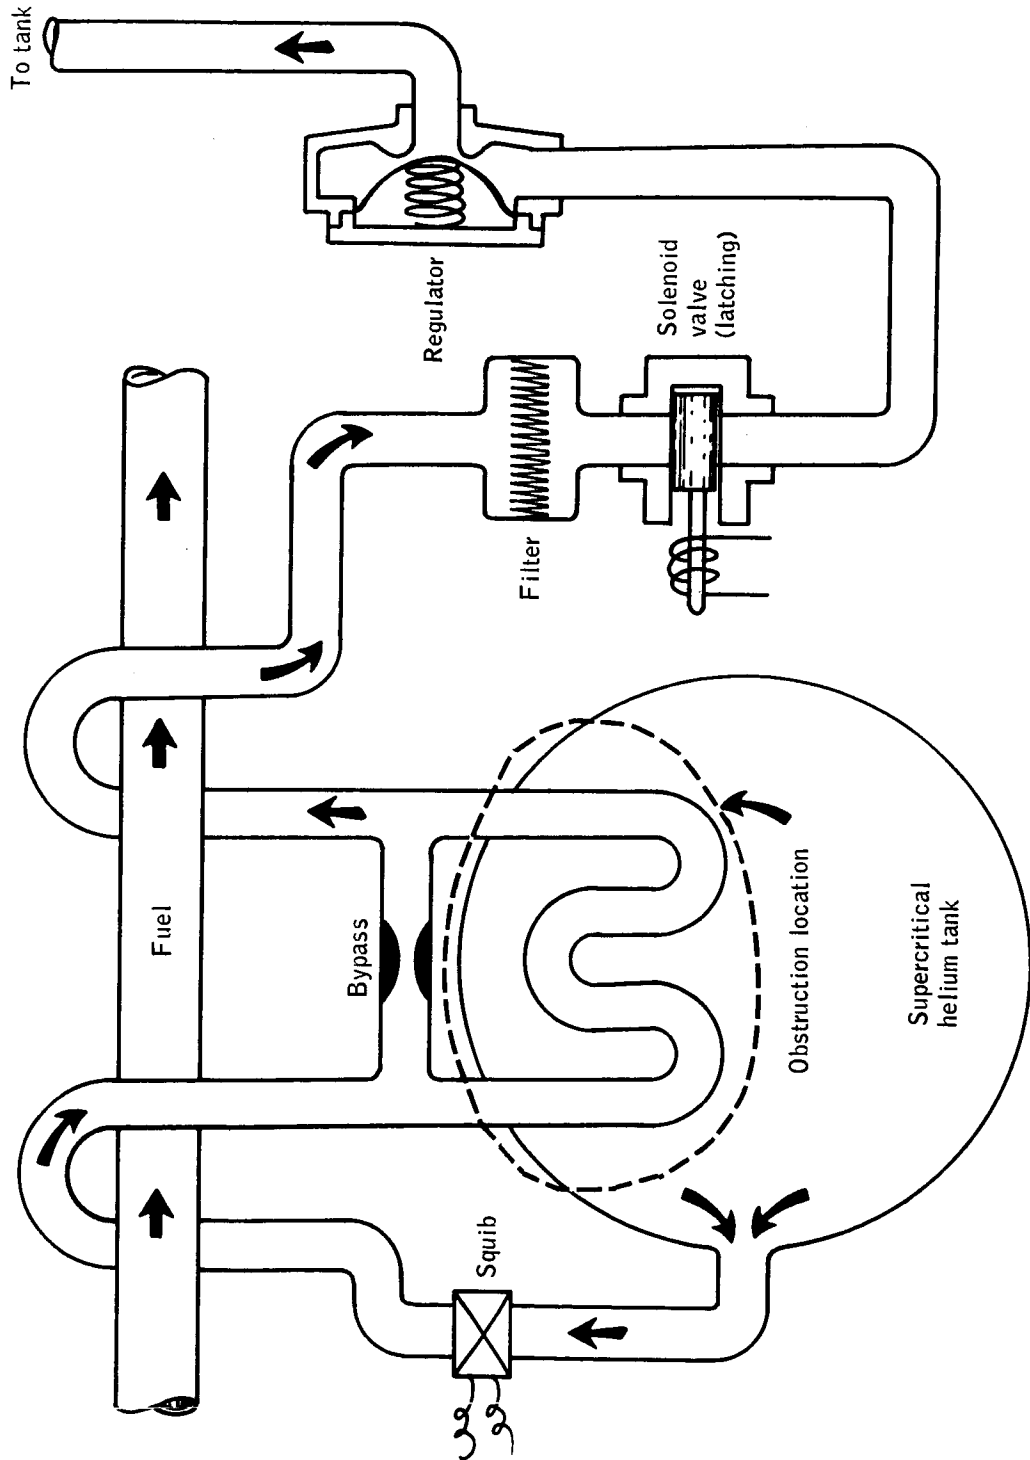
Figure 14.- Supercritical helium system .

During the first 30 seconds of the first descent engine firing, the descent propulsion helium regulator manifold pressure decayed to 180 psi and recovered to a normal value of 240 psia. All temperature, pressure, and flow indications substantiate a plugged heat exchanger in the supercritical helium system (see fig. 14); the plugging cleared during the firing (see fig. 15), as indicated by the pressure rise in the supercritical helium tank and the return to normal regulated pressure.

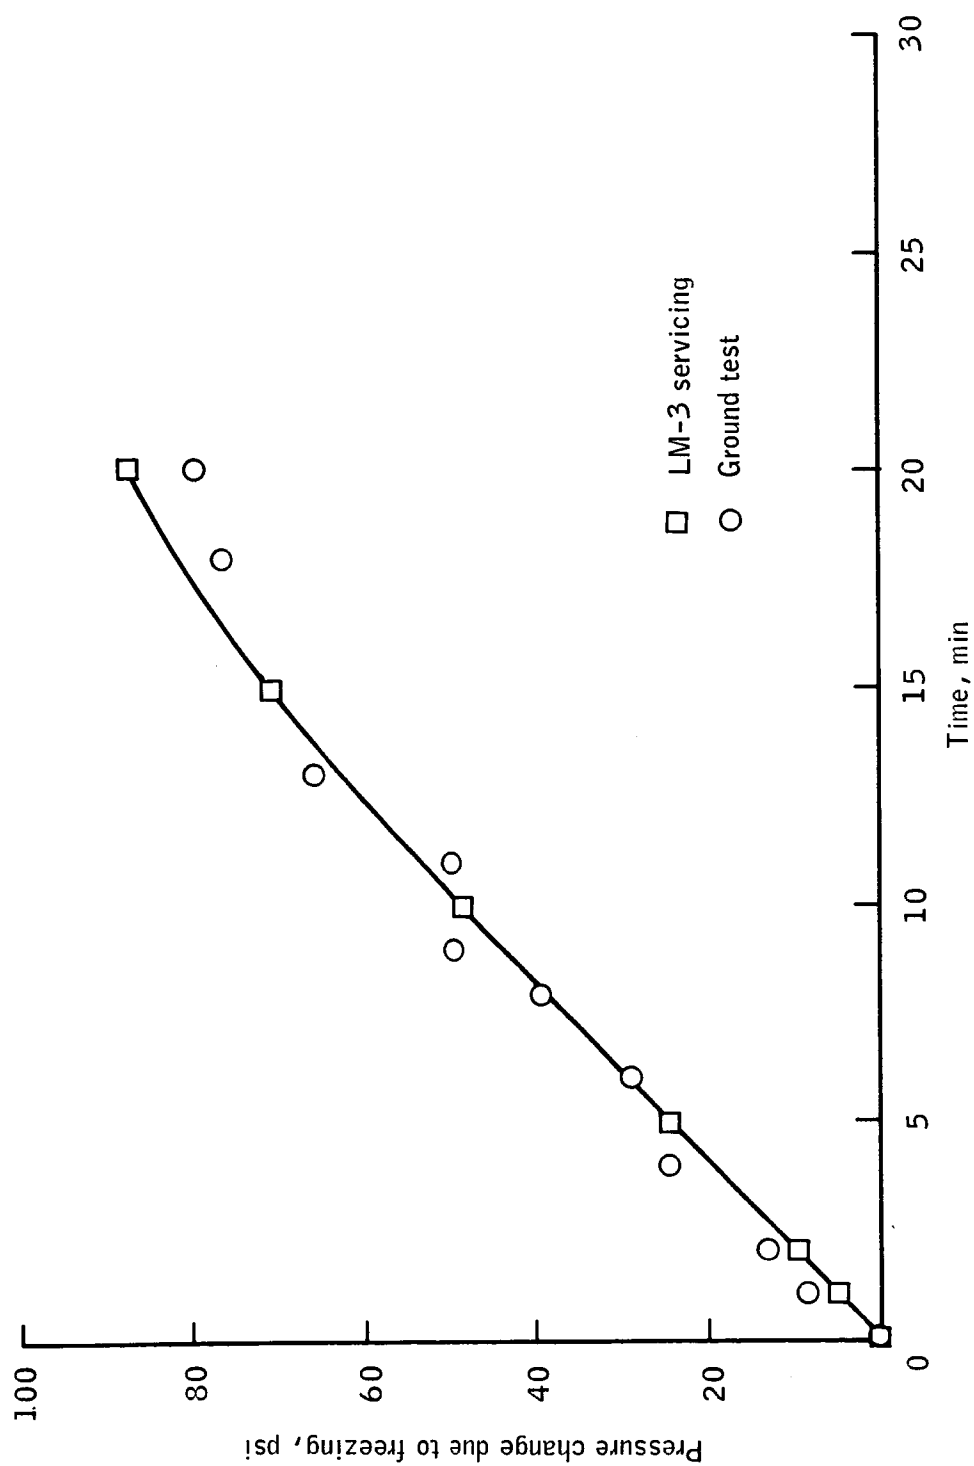
Figure 16.- Supercritical helium tank pressure rise.

During the LM-3 servicing, the pressure must have dropped to zero, allowing air to be drawn into the manifold by condensing out the incoming air in the supercritical helium tank heat exchanger. Tests have shown that dropping the manifold pressure to zero for about 30 minutes will allow air to be "cryo-pumped" into the manifold to the tank heat exchanger, where it will freeze and block the heat exchanger. The freezing process transfers heat into the supercritical helium tank, causing a pressure rise of about 90 psi, very similar to what occurred during the LM-3 top-off (see fig. 16). If no air were introduced, the tank pressure would be expected to rise 10 psi or less.

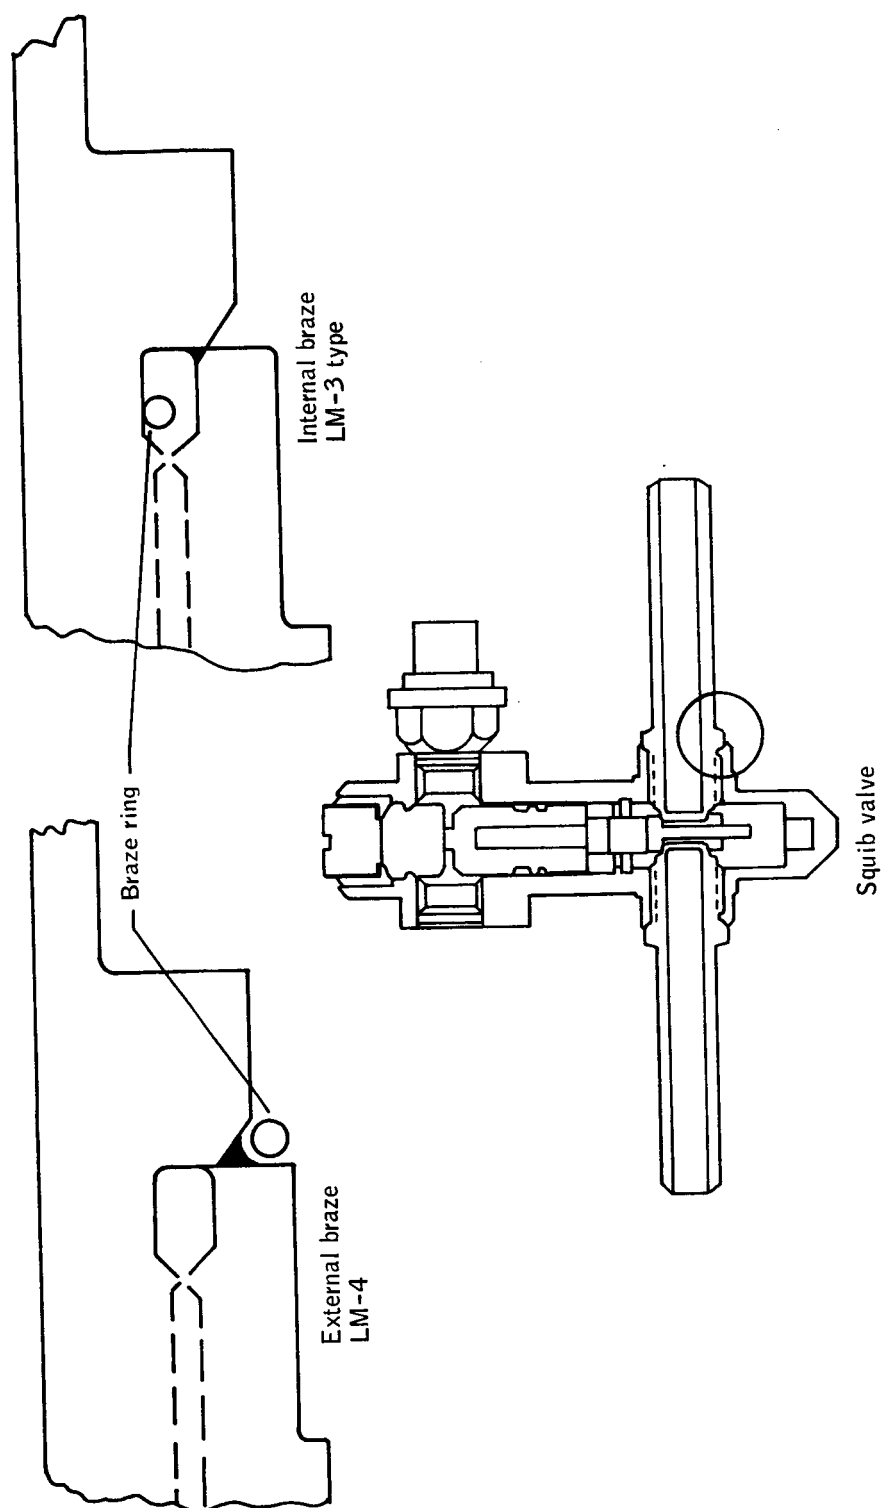
Figure 19.- Supercritical helium squib valve configurations .

The LM-3 squib valve differed from the LM-4 configuration in that the LM-3 valve fittings were internally brazed, preventing proper inspection of the joint. The LM-4 fittings are externally brazed (fig. 19).
